Manhole Inspection Summary

Manhole # S19II_034MH

Location Address: **1801 APPLETON-MONROE** Cross Street: **WESTWOOD AVE**

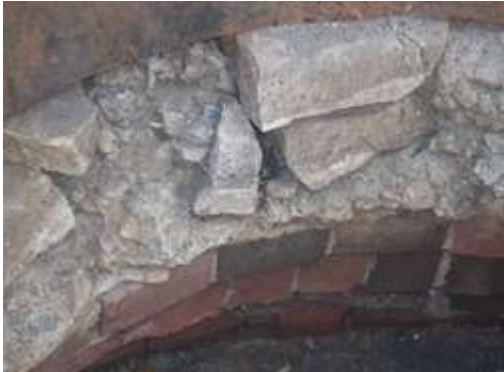
Defect 1

Chimney / Frame Adjustment ☒ Exists Material: **Concrete** ☐ Parged Height: **9** (in.)
Condition: ☐ Sound ☐ Cracked ☐ Root Intrusion ☐ Loose Brick ☒ **Deteriorated**
Infiltration: ☒ None ☐ Joint ☐ Cracks ☐ Mortar ☐ Roots ☐ Wall

DETERIORATION OF CHIMNEY

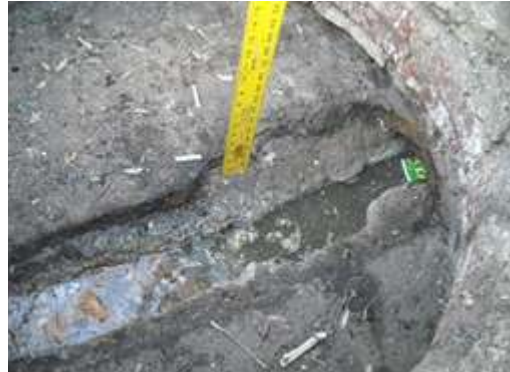
Defect 3

Comments **CAME TO RETAKE PHOTO - OBSERVED HEAVY GREASE IN LINE - THAT WAS THE DEBRIS IN CHANNEL. THE BENCH IS MISSING ABOUT 3 BRICKS - DETERIORATION. REWORK COMPLETE.**

Bench ☒ Exists Material: **Brick** ☐ Parged
Condition: ☐ Sound ☐ Cracked ☐ Root Intrusion ☒ **Deteriorated** ☐ Leaks ☐ Debris

Channel Material: **Brick** ☐ Parged
Channel Exposure: **Fully Open** Junc Dist: **0** nearest .5 ft. Azimuth:
Condition: ☐ Sound ☐ Cracked ☐ Root Intrusion ☐ Deteriorated ☐ Leaks ☒ **Debris**

THERE IS HEAVY GREASE IN THE CHANNEL - DEBRIS. THERE ARE BRICKS MISSING FROM THE BENCH -

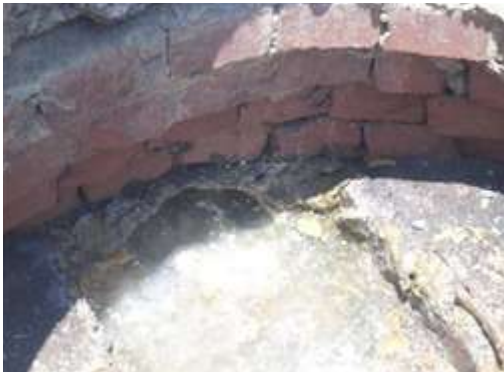
Defect 2

Barrel Material: **Brick** ☐ Parged
Shape: **Circular** Diameter: **46** (in.) Length: (in.)
Condition: ☐ Sound ☐ Cracked ☐ Root Intrusion ☐ Loose Brick ☒ **Deteriorated**
Infiltration: ☒ None ☐ Joint ☐ Cracks ☐ Mortar ☐ Roots ☐ Wall

DETERIORATION OF BARREL

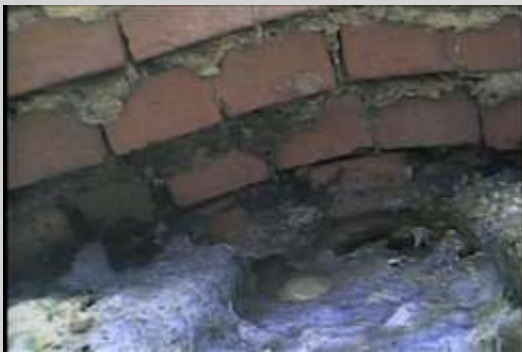
12 O'Clock Outflow

8 in. Circular Gravity Sewer
Pipe Out @ 12 O'Clock

Pipe Height: **7.2** (in.) Rod and Bar (Angled)
Pipe Material: **Clay** ☐ Pipe Lined
Invert Depth: **3.04** (ft.) Flow Characteristics: **Slow**
Deposits: ☐ None ☐ Mud ☐ Sludge ☒ **Debris** ☐ Grease
Silt Depth: **3** (in.) Deposits Extent: **Medium**
Infiltration: **None** Pipe Seal Cond: **Sound**

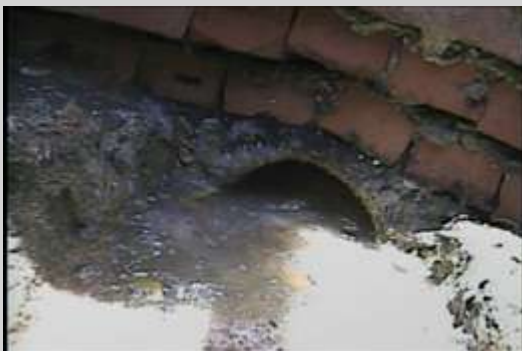
6 O'Clock Inflow

8 in. Circular Gravity Sewer
Pipe In @ 6 O'Clock

Pipe Height: **8.4** (in.) Rod and Bar (Angled)
Pipe Material: **Clay** ☐ Pipe Lined
Invert Depth: **2.99** (ft.) Flow Characteristics: **Slow**
Deposits: ☐ None ☐ Mud ☐ Sludge ☒ **Debris** ☐ Grease
Silt Depth: **3** (in.) Deposits Extent: **Medium**
Infiltration: **None** Pipe Seal Cond: **Sound**
